# Analysis of the Cause of Collapse of World Trade Center 7

## Progression of the Project Daily Report

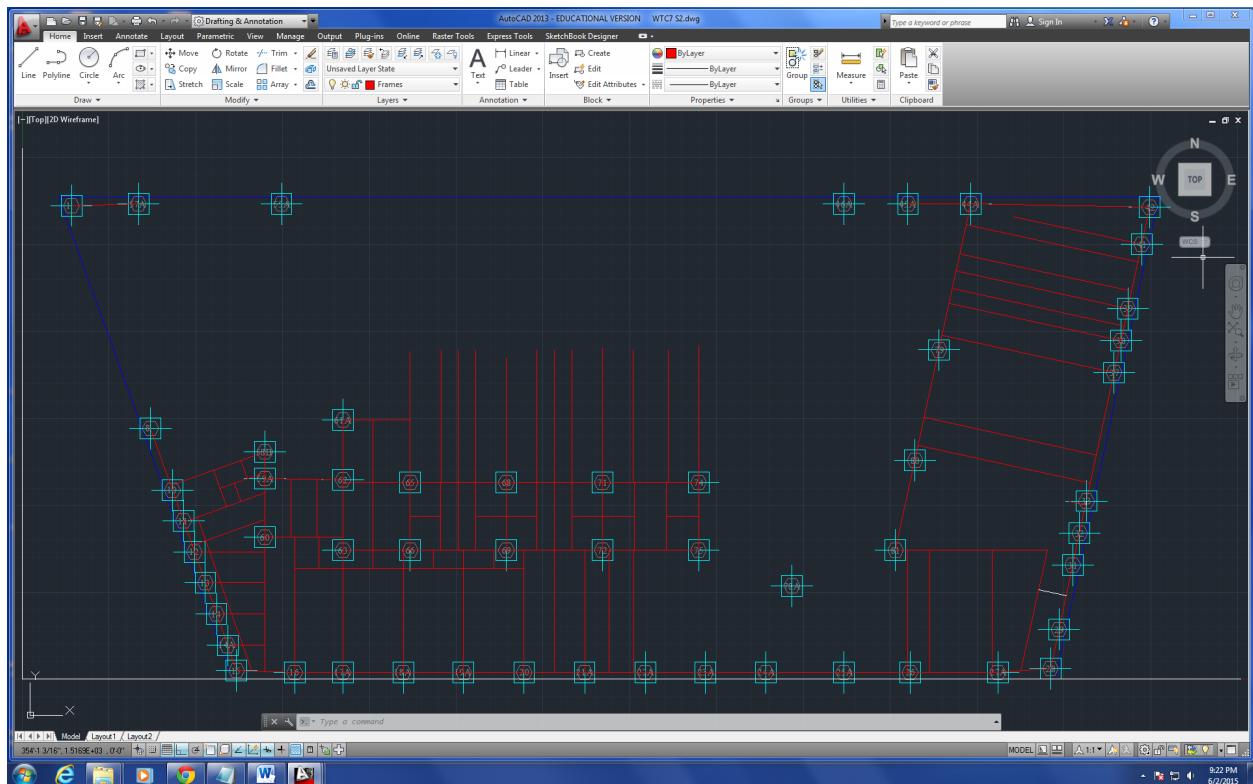
Figure 1

Today, the drawing of floor framing of the 2<sup>nd</sup> floor is finished. The following figure shows the framing plan.

Again, only changes were made from the 1<sup>st</sup> floor framing, and only part of it can be drawn as well due to the missing blueprint of the electrical substation.

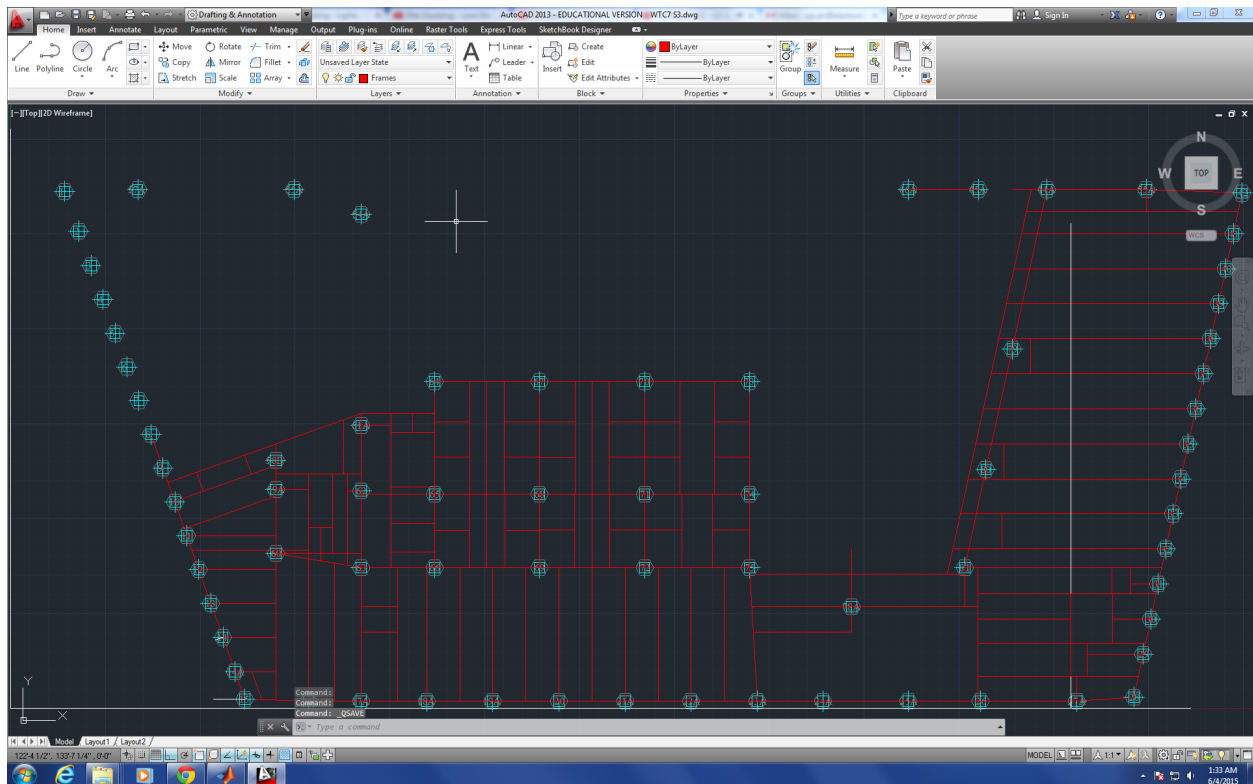
Figure 1

Today, the drawing of floor framing of the 3<sup>rd</sup> floor is finished. The following figure shows the framing plan.

Again, only changes were made from the previous floor framing, and only part of it can be drawn as well due to the missing blueprint of the electrical substation.

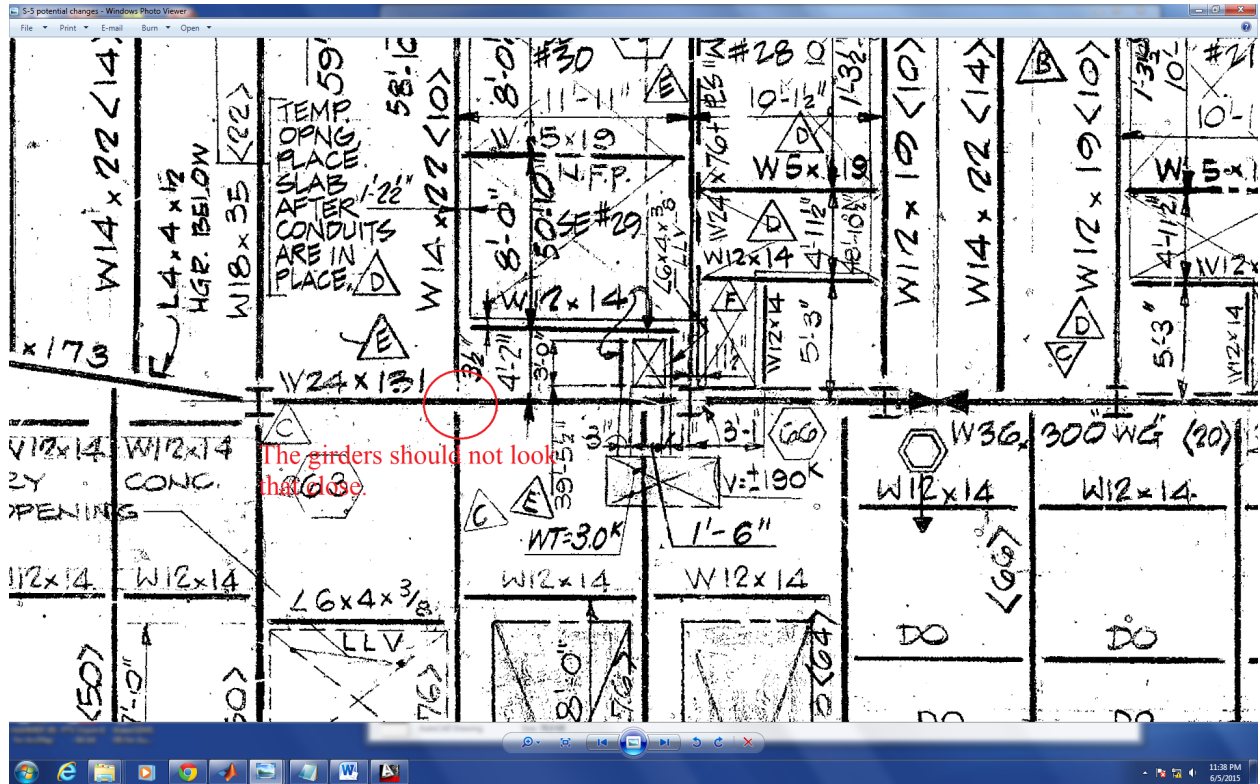
Figure 2

Also, a little dimension off of girders on the 5<sup>th</sup> floor framing plan is found and to be confirmed. The following figure shows it.

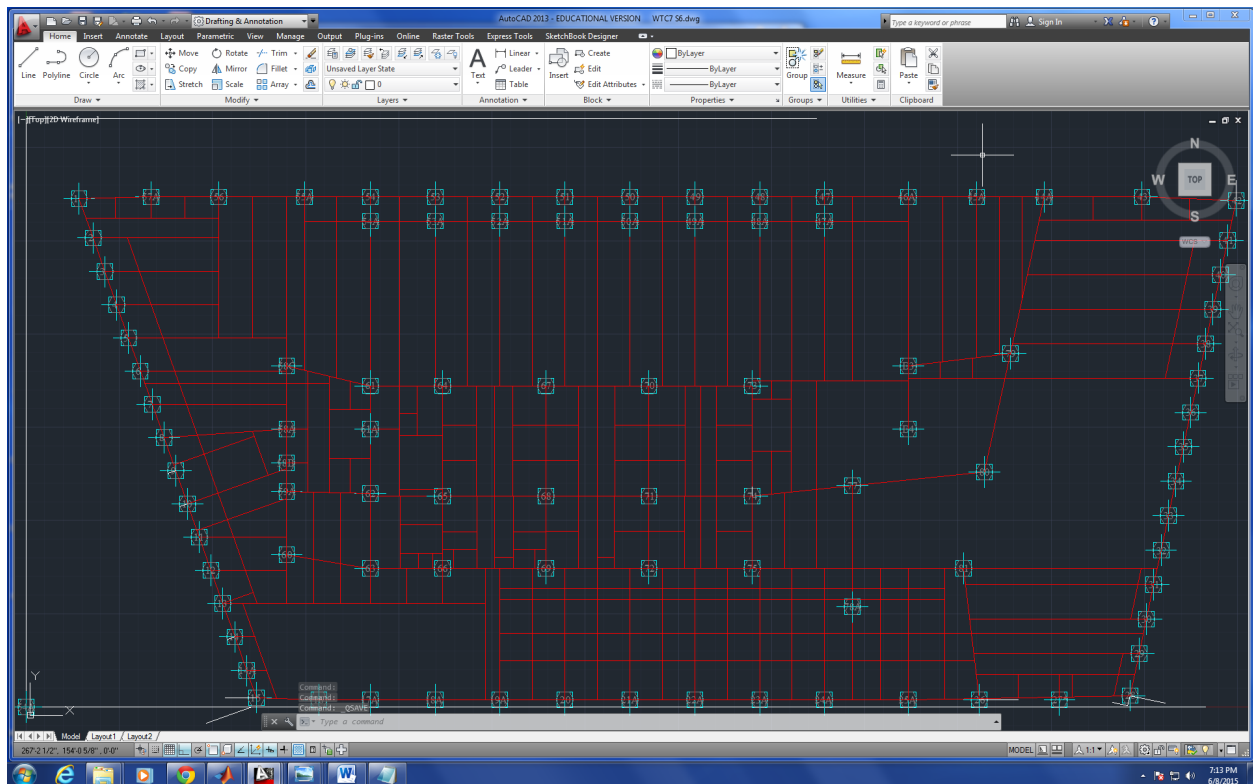
Figure 1

Today, the drawing of the 5<sup>th</sup> floor framing plan has been finished. The drawing of the 6<sup>th</sup> is also finished but more issues have been found. The following figure shows the 6<sup>th</sup> floor framing plan view.

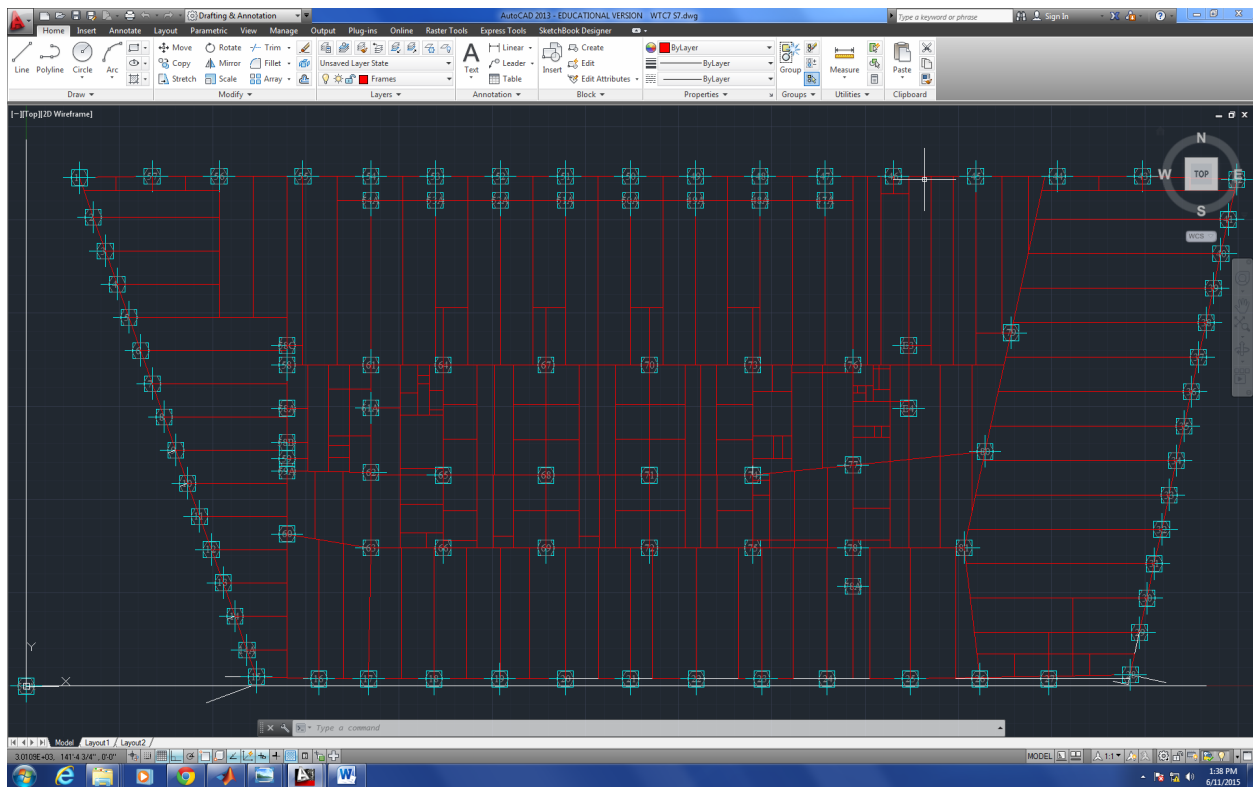
Figure 1

Today, the drawing of the 7<sup>th</sup> floor framing plan was finished. The drawing of the floor framing plan for floor 21 has started. Also, it turns out that the floor framing plans for floor 21 to 23 are exactly the same. The following figure shows the finished AutoCAD drawing of the 7<sup>th</sup> floor.

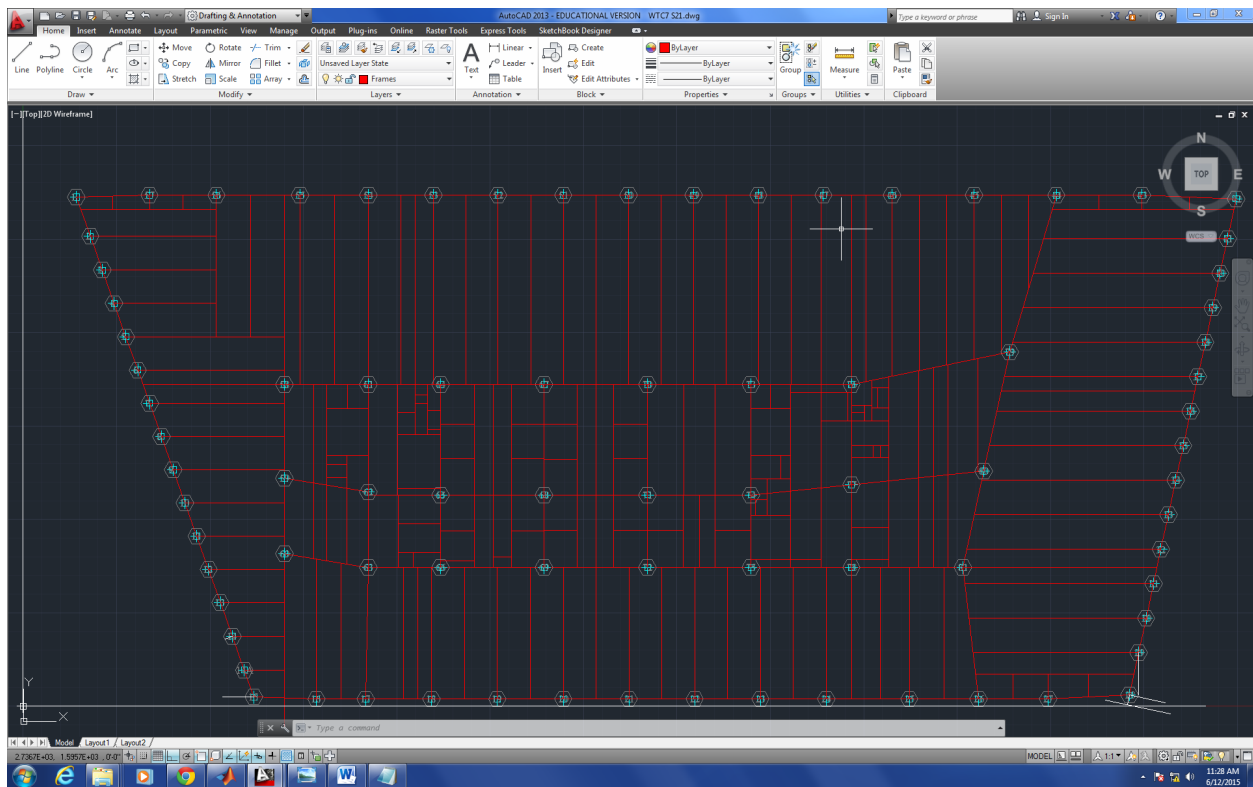
Figure 1

Today, the drawing of the 21<sup>th</sup> floor framing plan was finished. It is found that there is somehow minor difference between floor framing plan view between 21<sup>th</sup> floor and 22<sup>nd</sup> & 23<sup>rd</sup> floors. The 21<sup>th</sup> floor framing plan view is presented in the following figure.

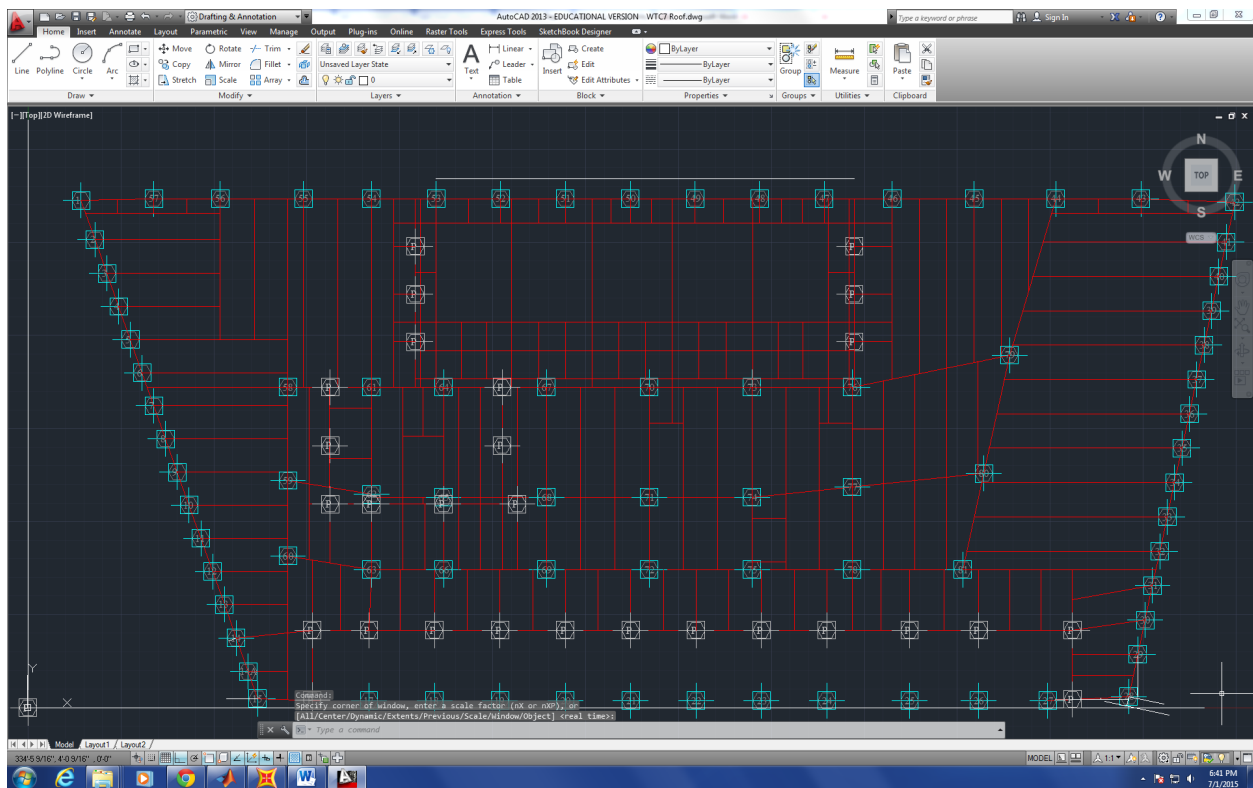
Figure 1 shows the finished plan view of the roof framing of WTC7.

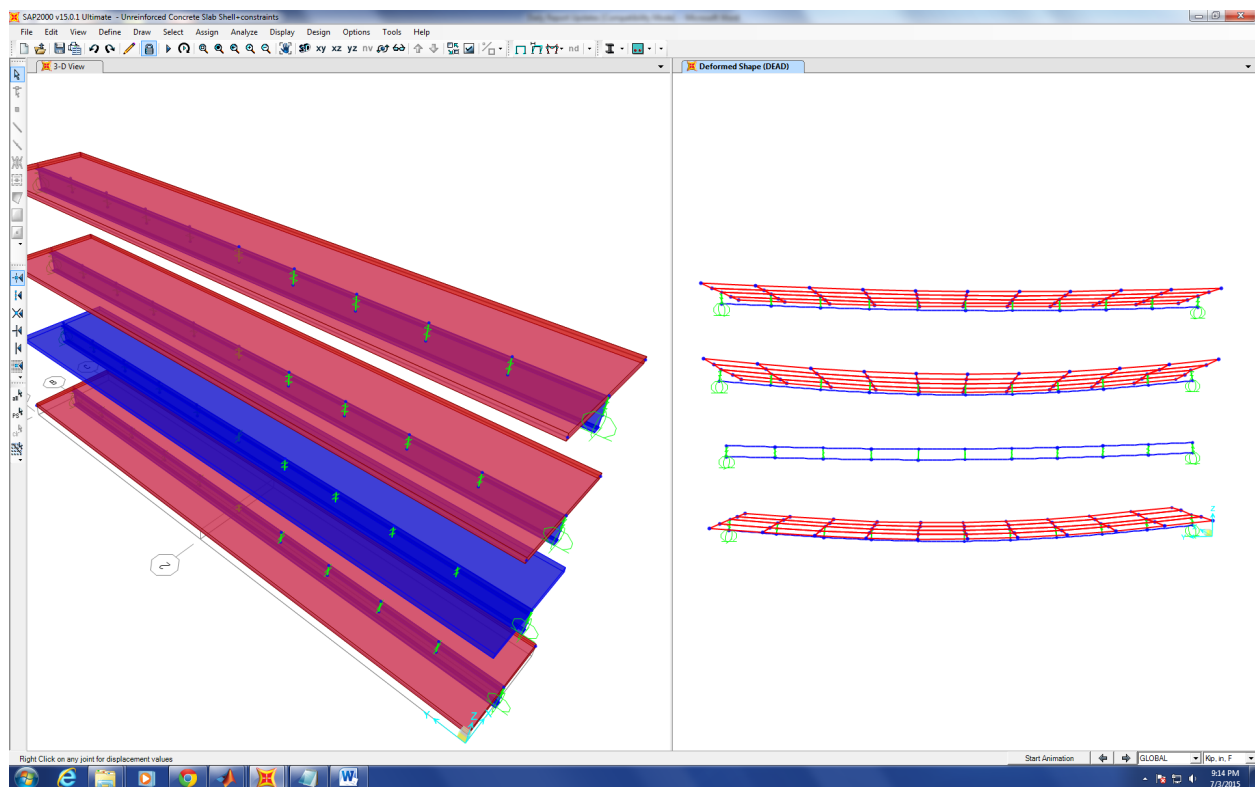
Today, a tentative model was done on SAP2000. In the case, the model was built for the chosen simple case of composite beam consisting of concrete slab on top and W-beam on bottom. Unlike the previous study, in which both the concrete slab and W-beam were analyzed as "beam" elements, the concrete slab was analyzed as "shell" ("thin" or "thick") element and the W-beam was analyzed as "beam" element. The concrete slab was meshed into sub-elements and each element was rigidly connected to W-beam underneath with link elements that are fixed in all 6 degrees of freedom. Figure 1 gives the modelling diagram and the deflection diagram under self-weight loading.

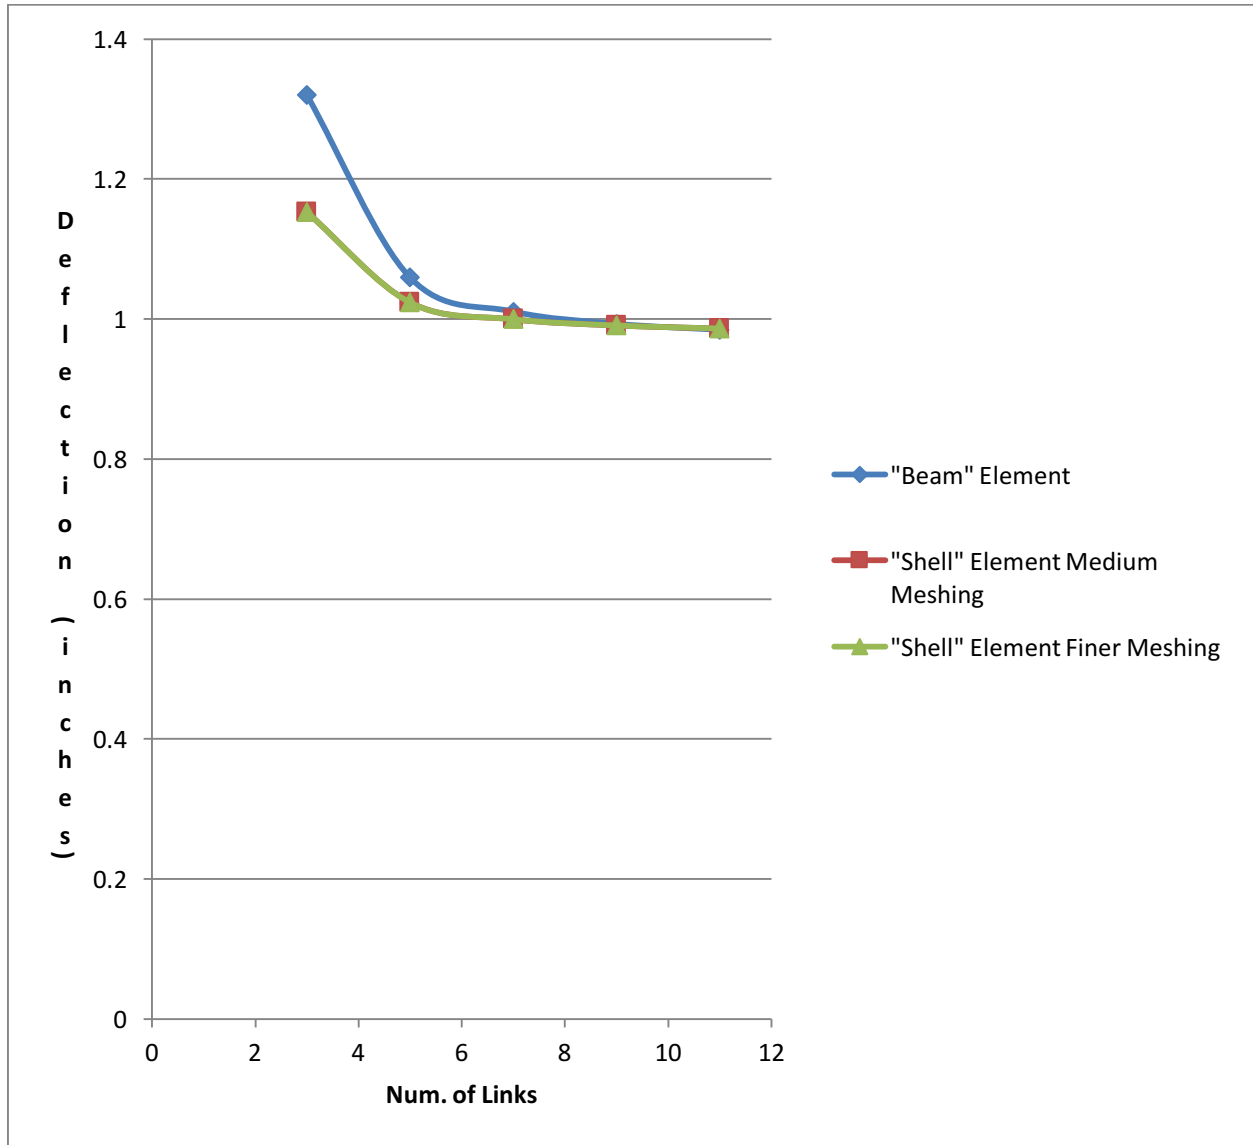
Results(max. deflection@CL) (in)	Number of Links	Number of Elements
1.1526	3	$4*2=8$
1.0238	5	$4*4=16$
0.9998	7	$4*6=24$
0.991	9	$4*8=32$
0.9866	11	$4*10=40$

Figure 1: Response of the Composite Beam vs. Number of Rigid Links for Different Elements

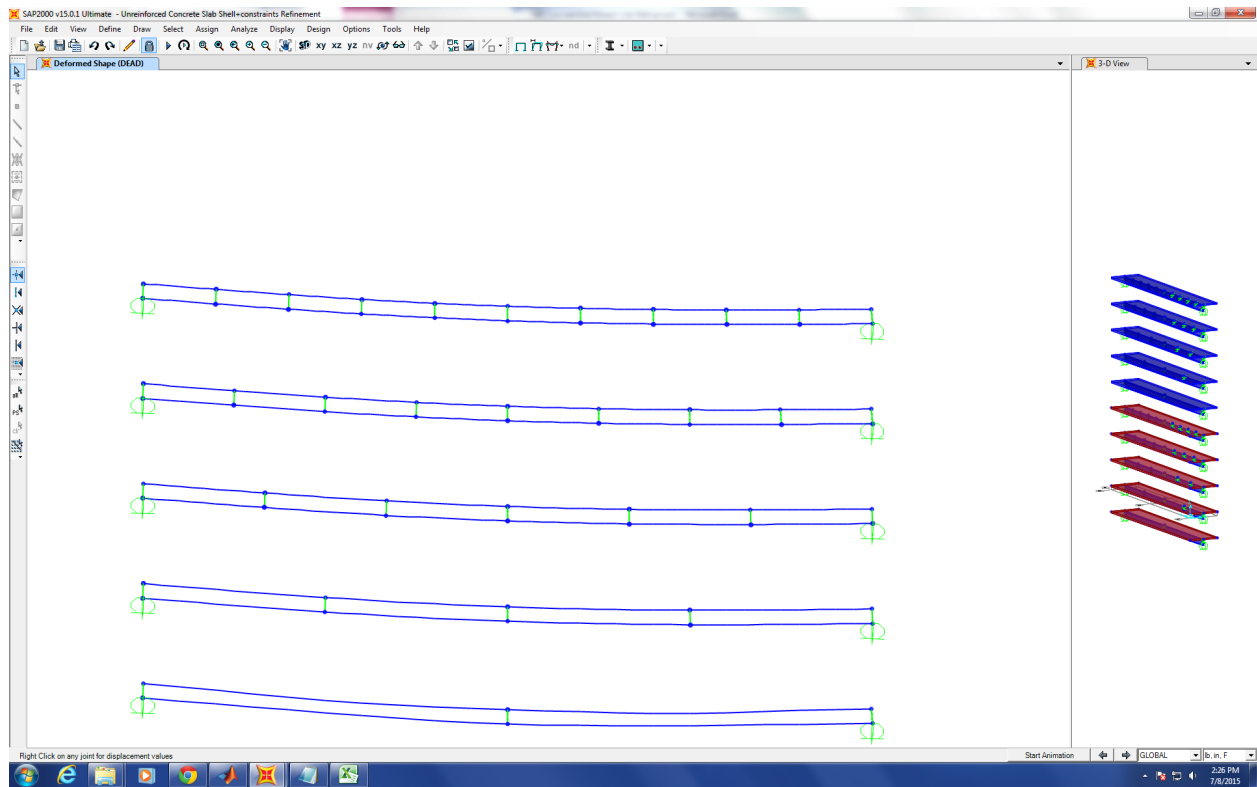
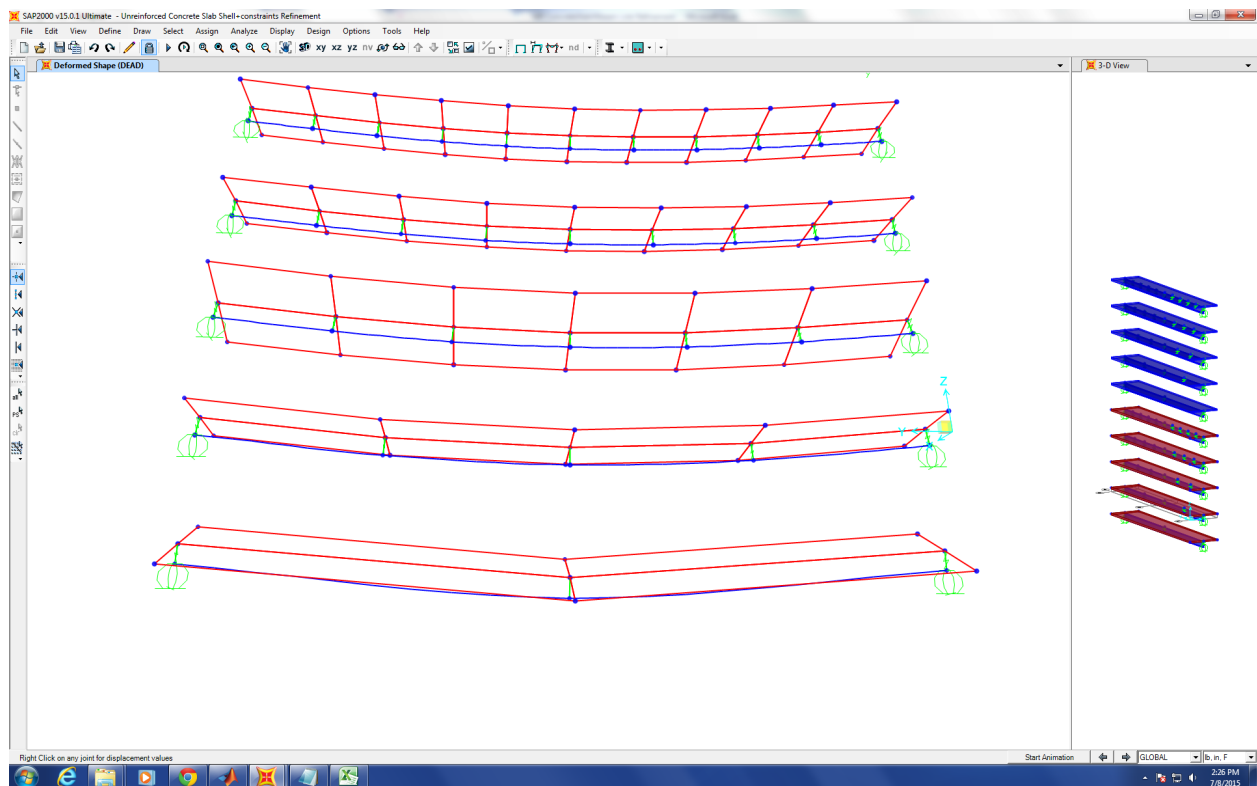
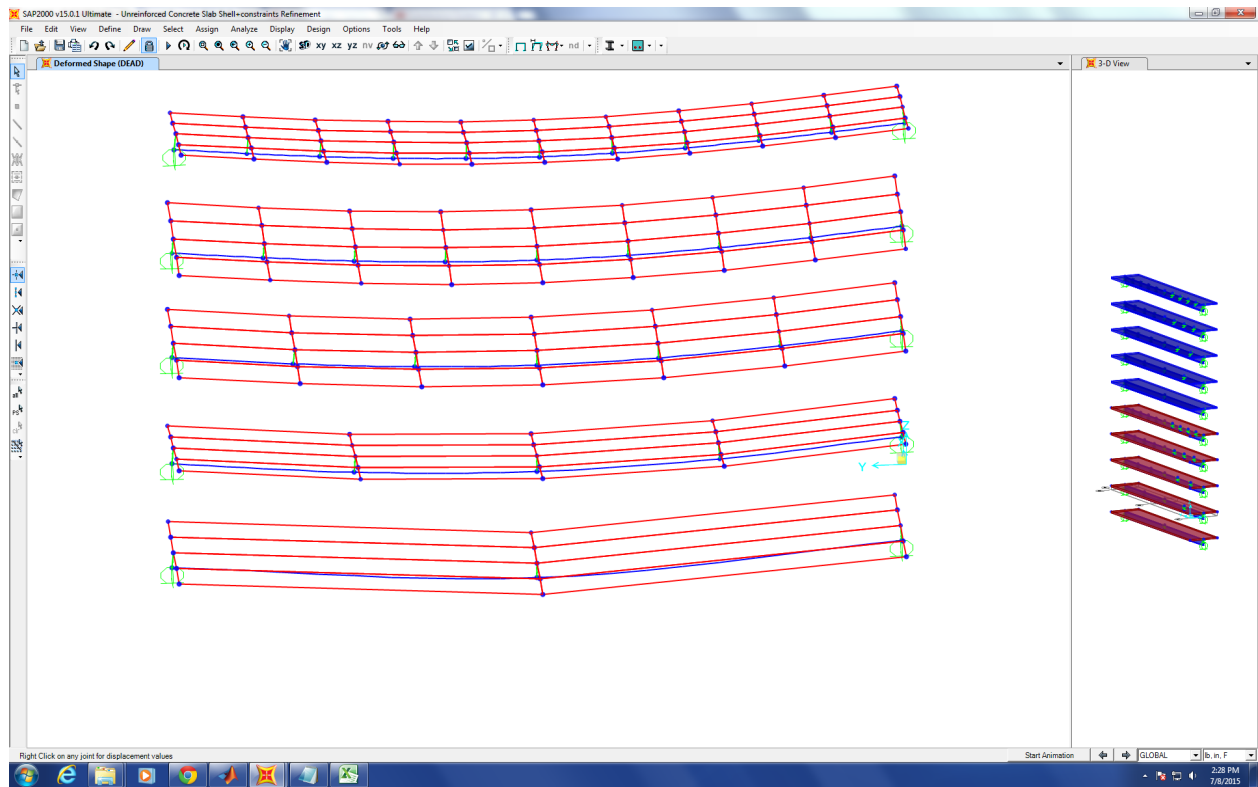
Figure 2 to Figure 4 show the different meshing techniques and different elements used to model the composite beams.

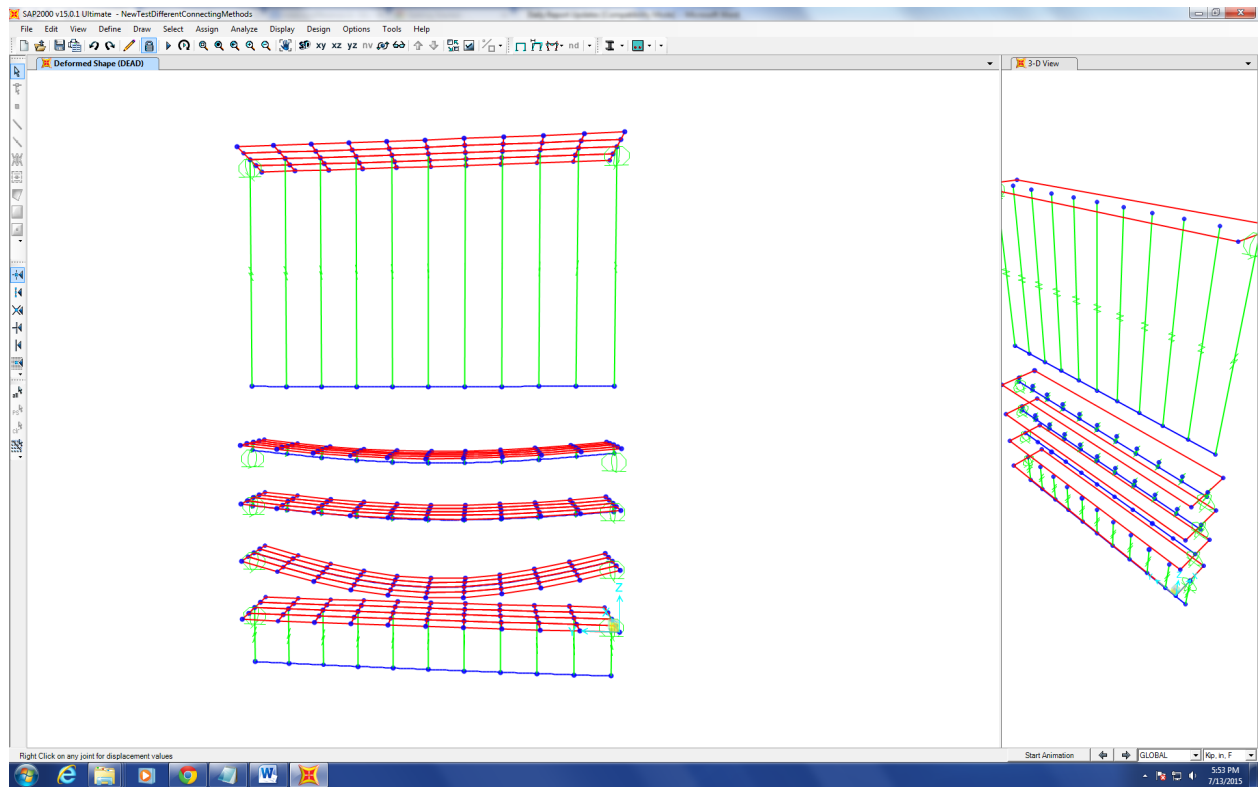
However, it was later found that the distance between the centroid of the concrete slab floor and the centroid of the member makes a fair amount of difference on the deflection calculated.

Figure 2 shows the difference in deflection caused by difference distances between the centroid of the concrete slab floor and the centroid of the member.

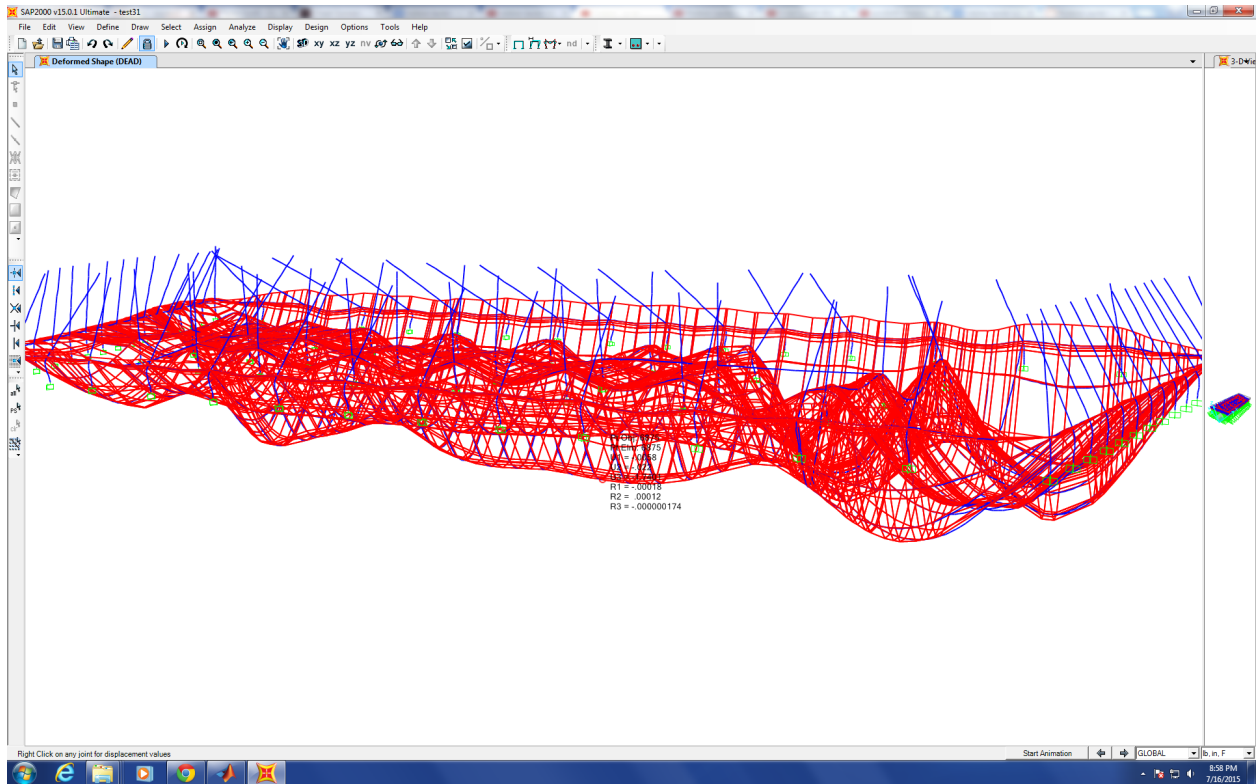
Figure 2 shows the deflection of the model under self-weight. The deflection is greatly exaggerated and the results make sense on the first sight numerically and intuitively. It can be observed that the floors are acting together with the beams on the figure. The results have to be checked with structural analysis in the next step.

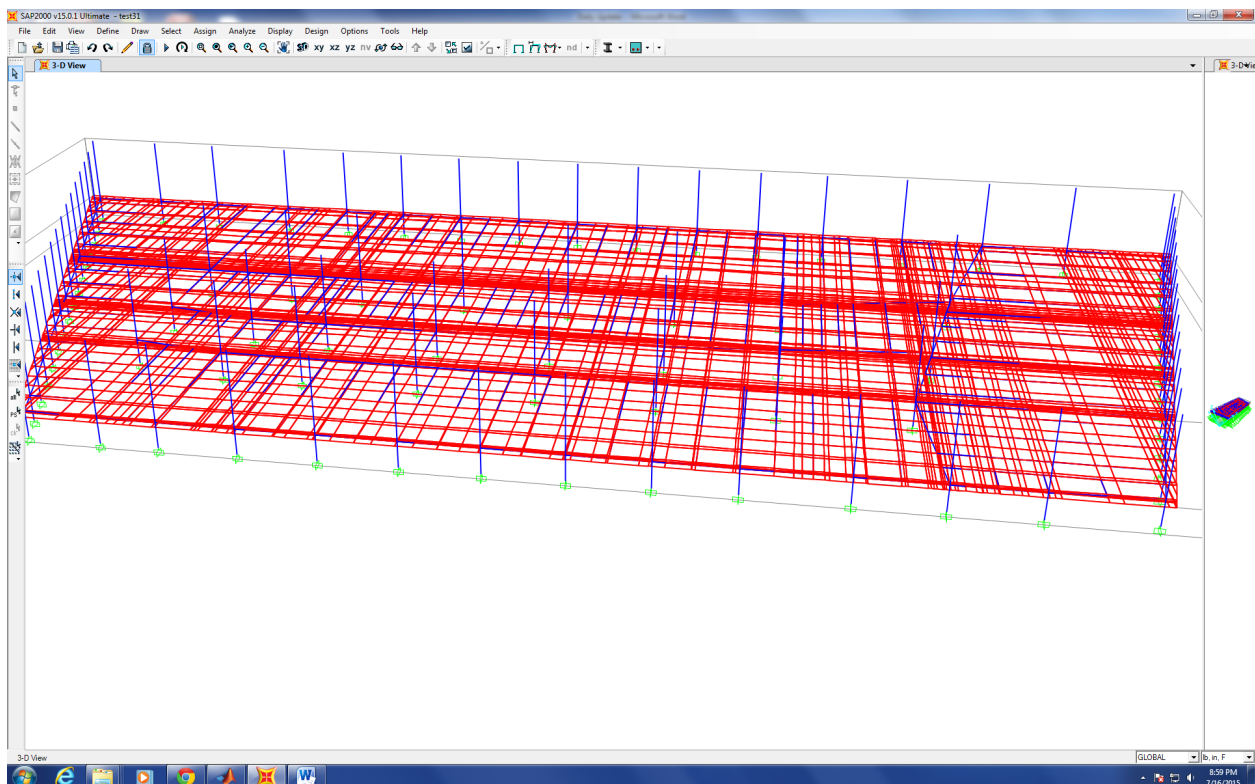
Figure 1 shows the meshed two “shell” elements representing the concrete slab floors stacked on top of each other connected by “frame” element representing columns laid out vertically. In the figure, only the two “shell” elements are meshed. All the “frame” elements are modelled as whole pieces.

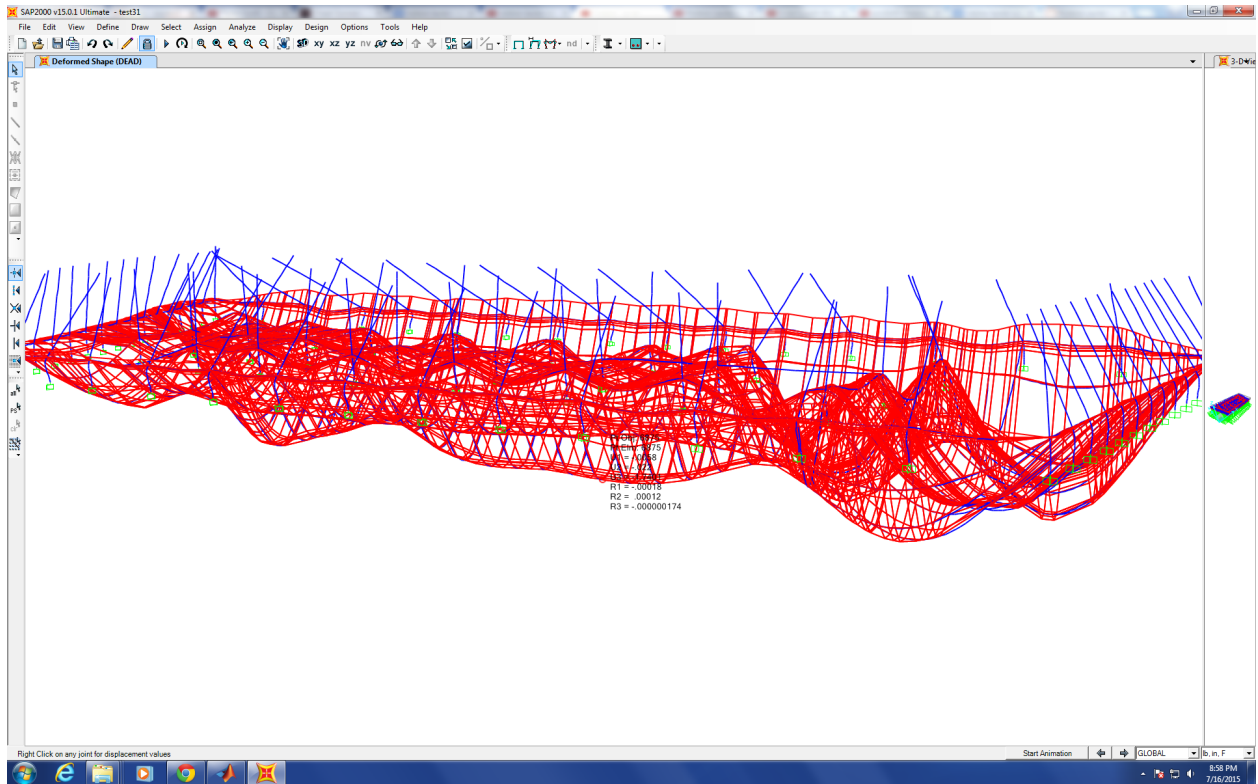
Figure 2 shows the deflection of the model under self-weight. The deflection is greatly exaggerated and the results make sense on the first sight numerically and intuitively. It can be observed that the floors are acting together with the beams on the figure. The results have to be checked with structural analysis in the next step.

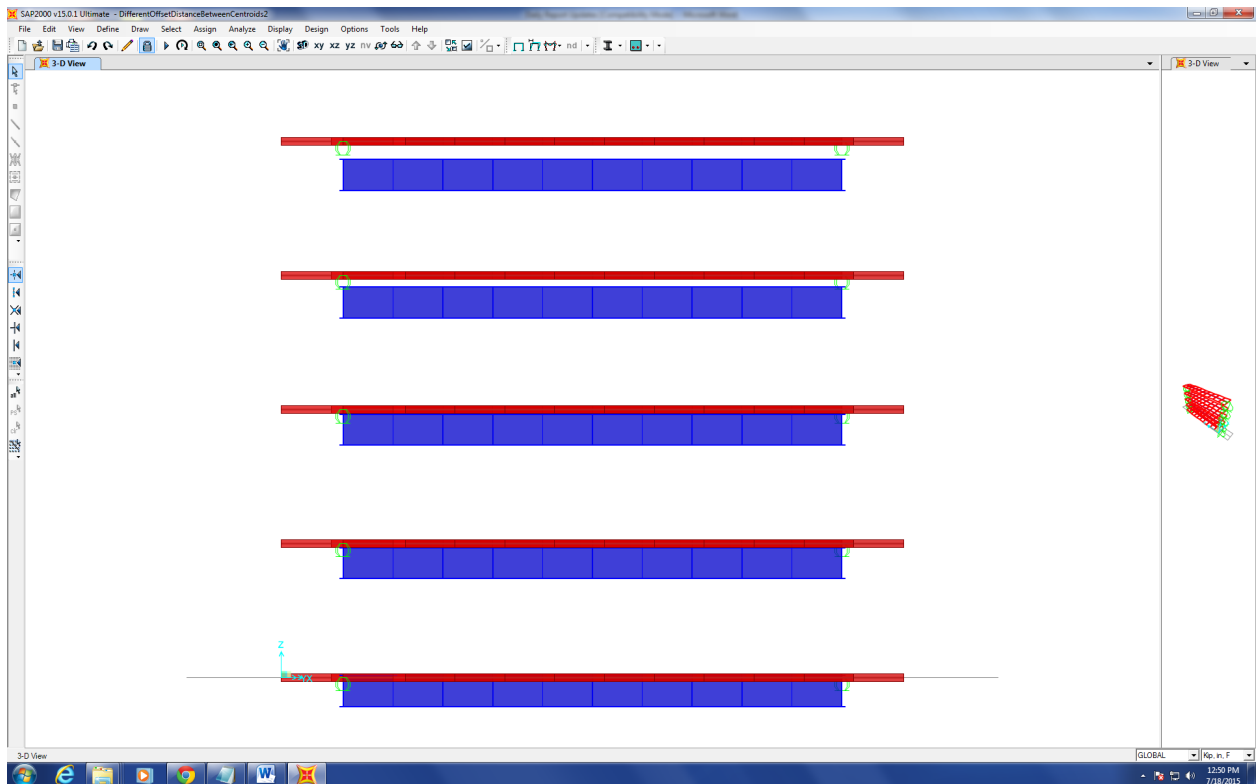
Figure 1 and 2 show the side views of the composite beams with different centroid distances.

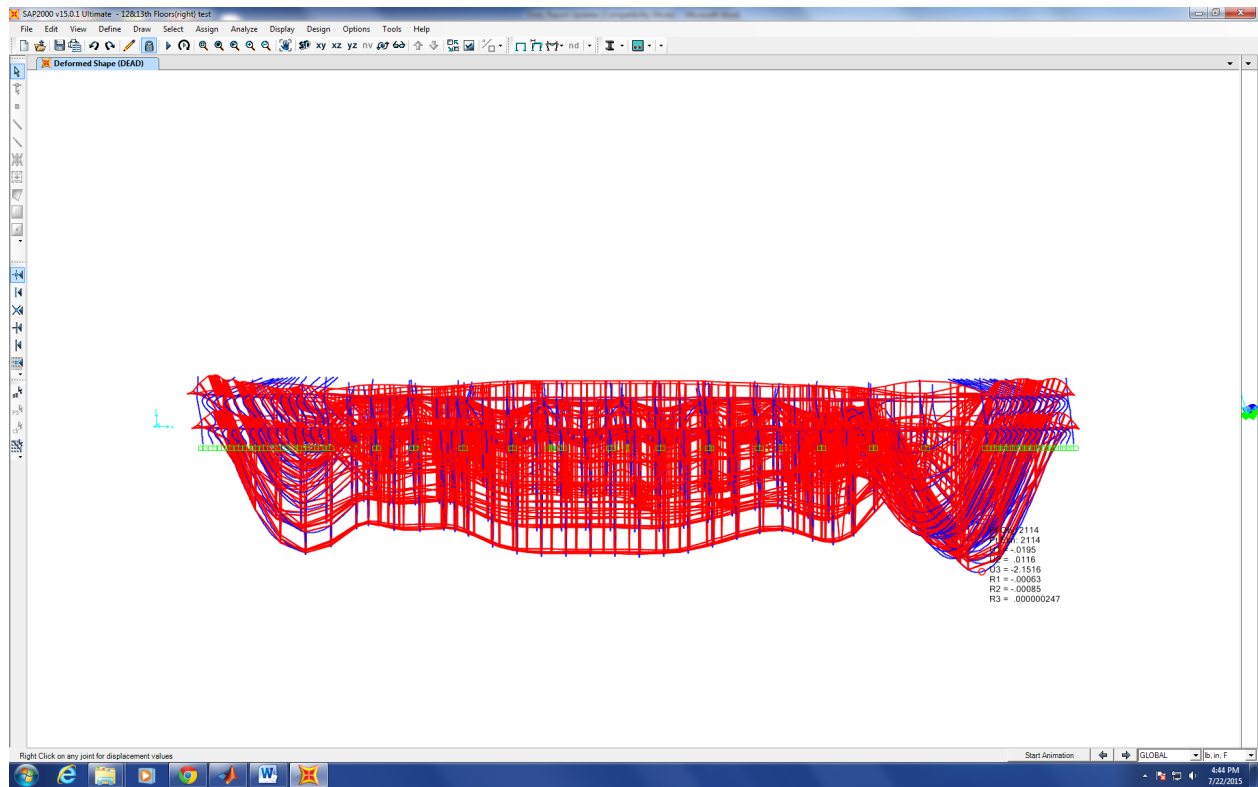
Figure 2 shows the response of the model under self-weight loading. The deflection is greatly exaggerated. The deflection makes sense both intuitively and numerically.

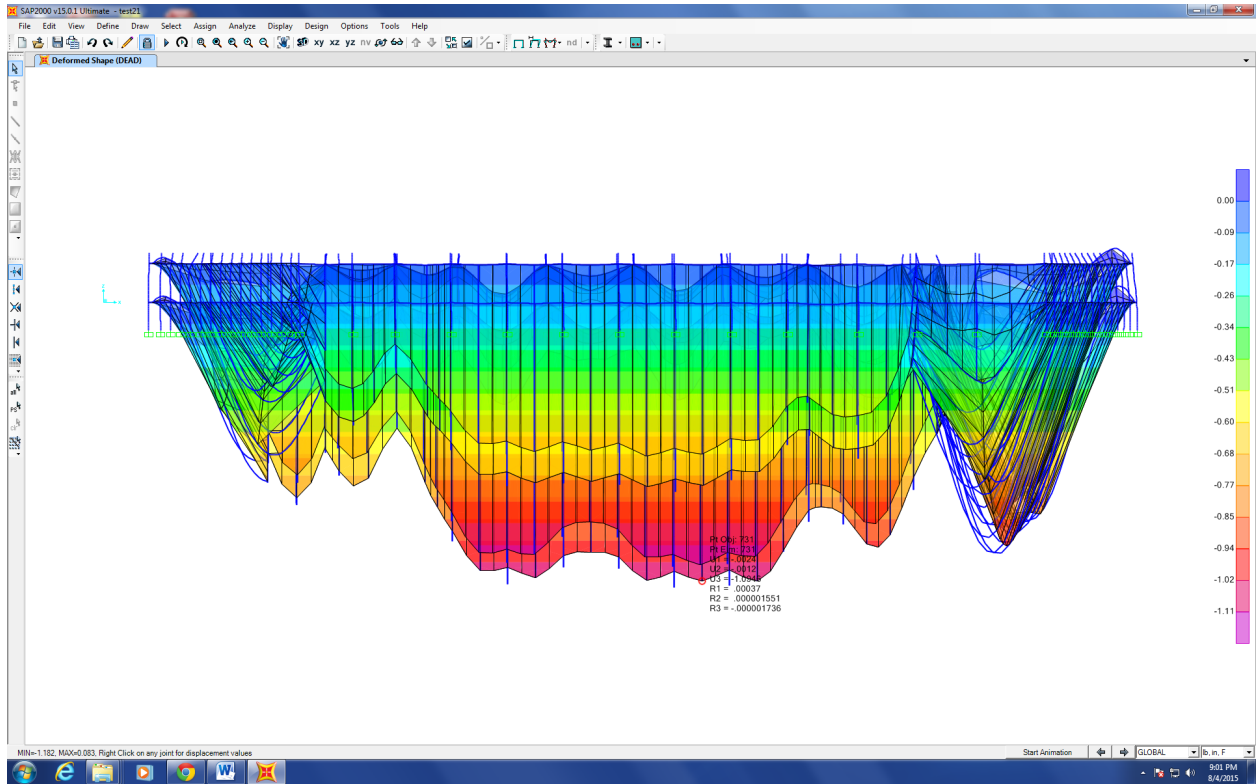
Figure 7. 2X2 elements between frame divisions with frame meshing

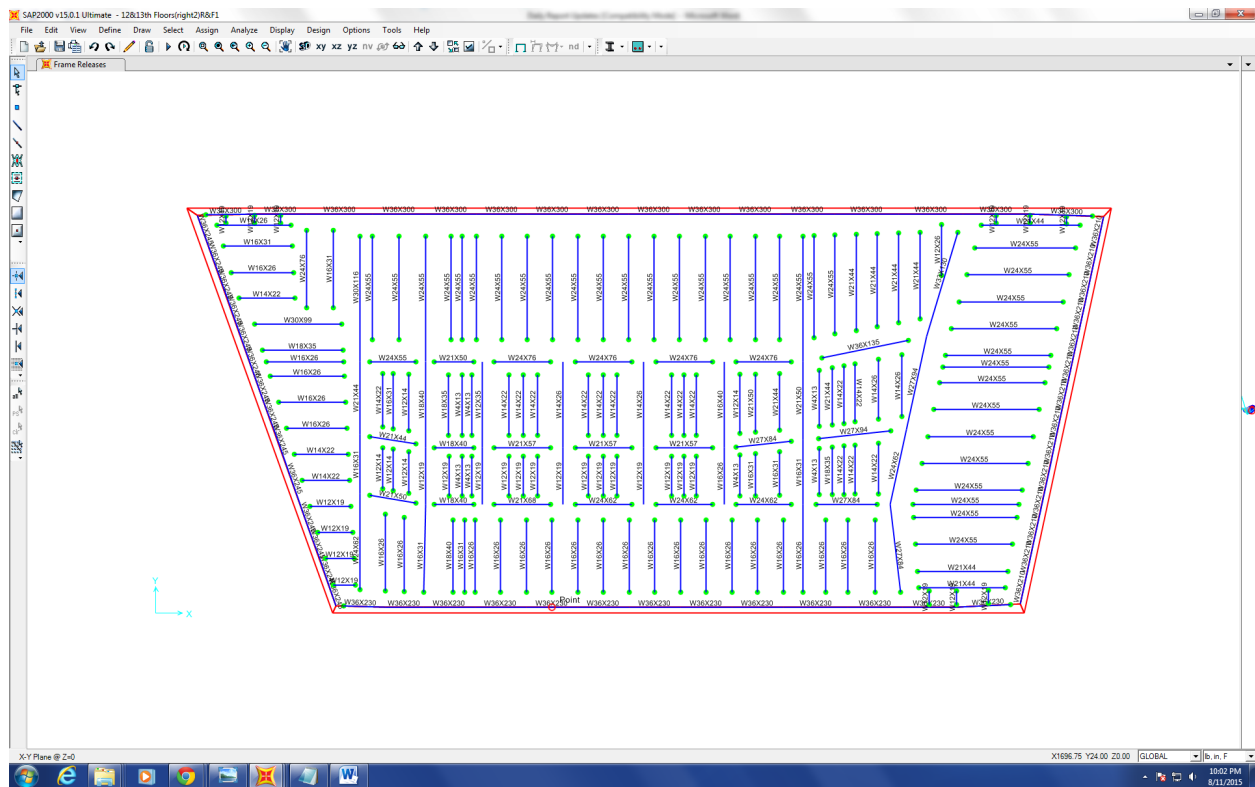
Figure 1 shows the new model with mostly released connections and some remaining fixed connections.

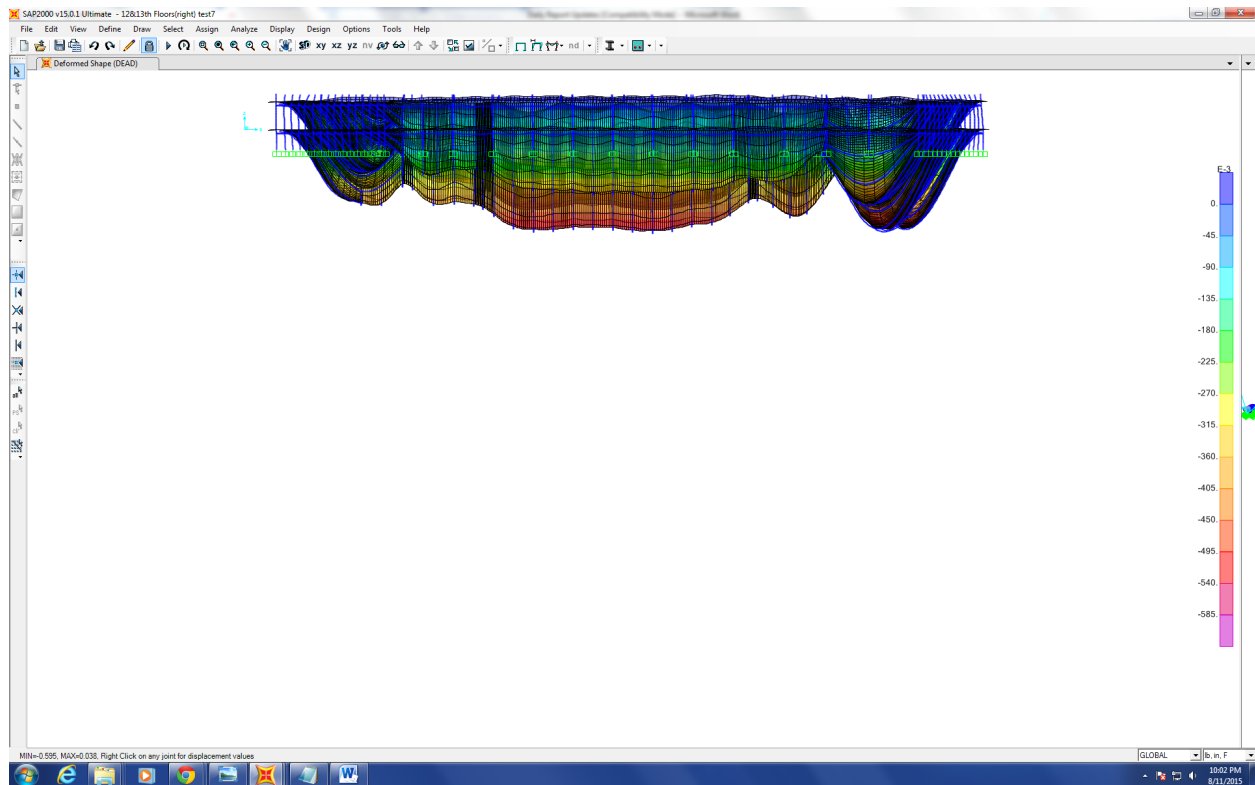
Figure 2 shows the analyzed deflection contour of the new model on SAP2000.
