# Analysis of the Cause of Collapse of World Trade Center 7

## Progression of the Project Daily Report

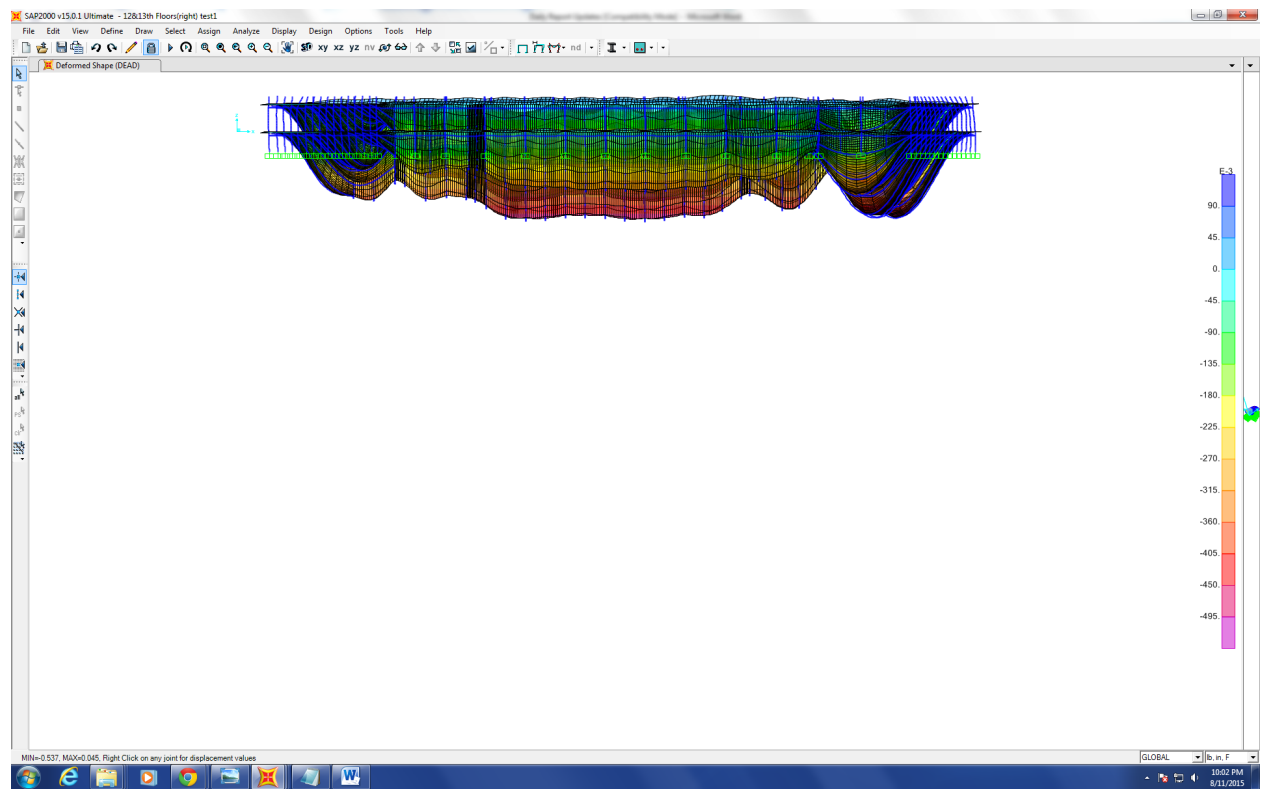
Figure 3 shows the analyzed deflection contour of the original model with all the connections fixed. The deflection is about 15-20% smaller.

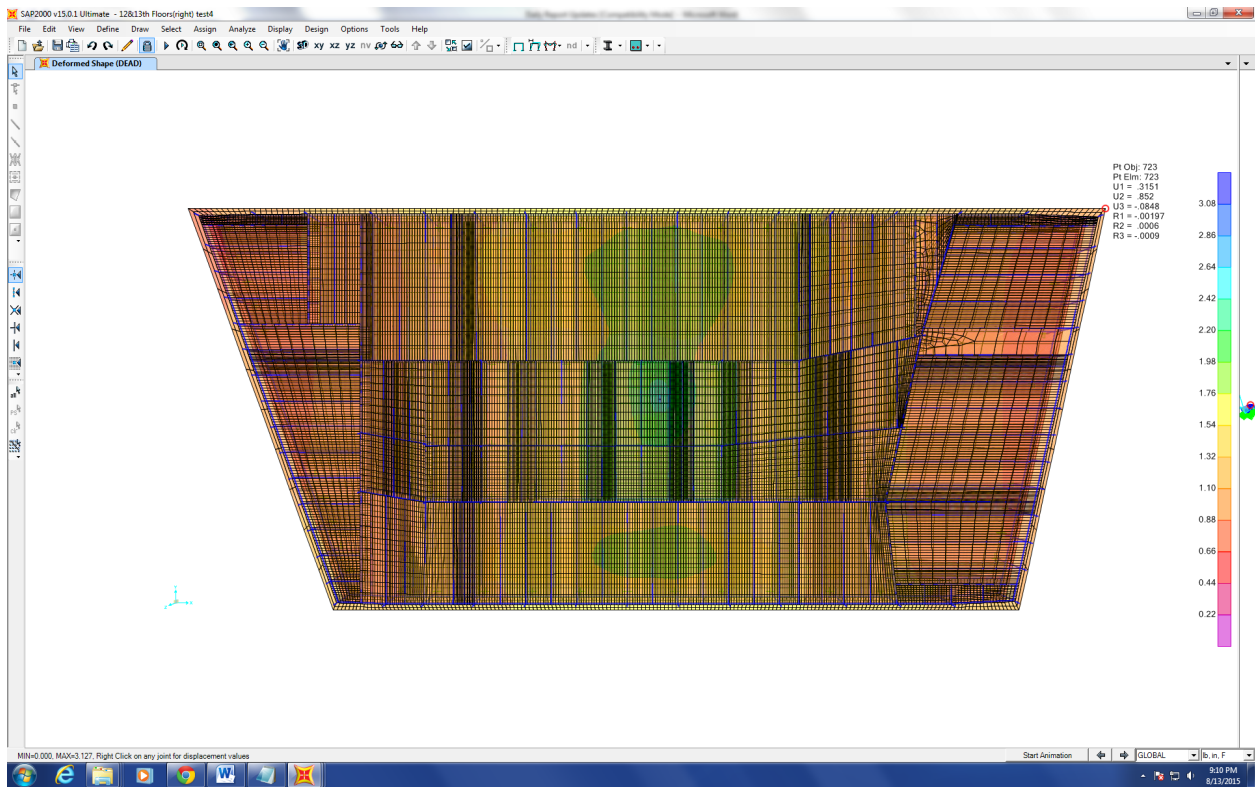
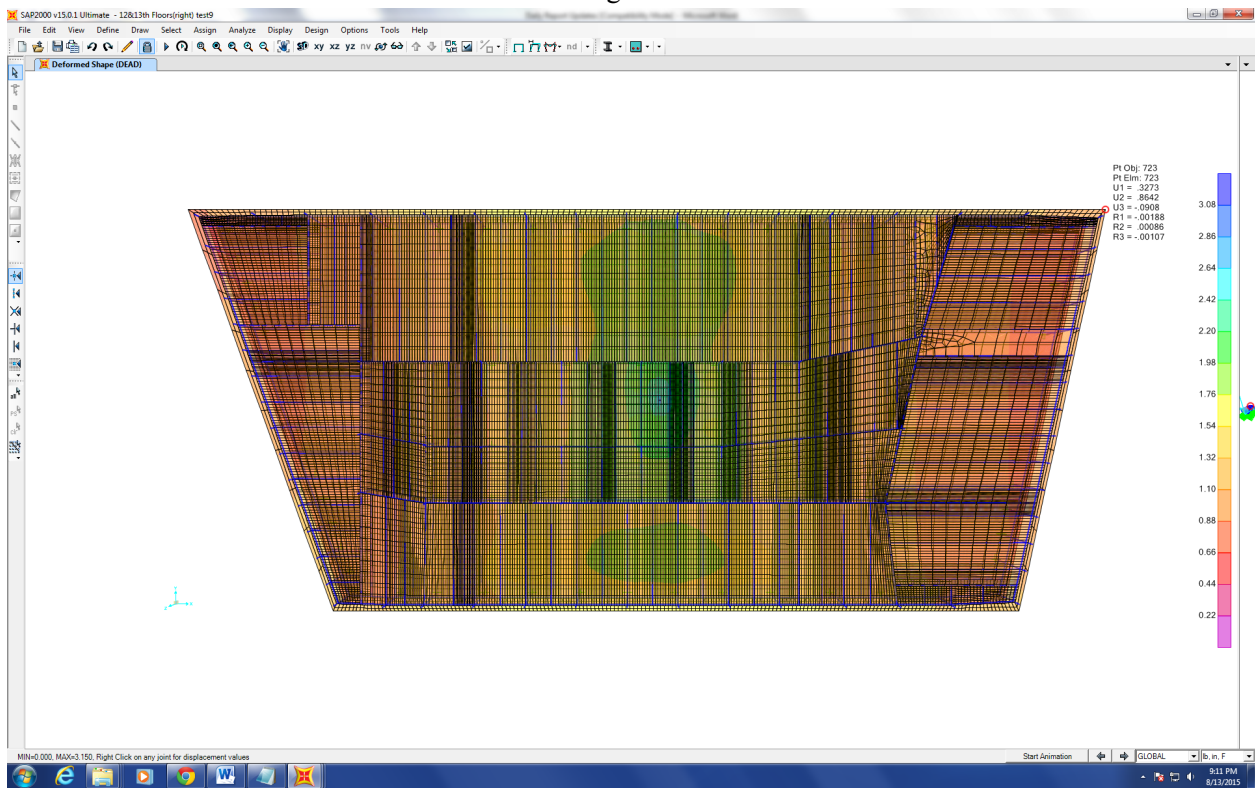
Figure 3 and 4 show the deflection of the original model and the modified model under 10,000kips in y direction respectively.

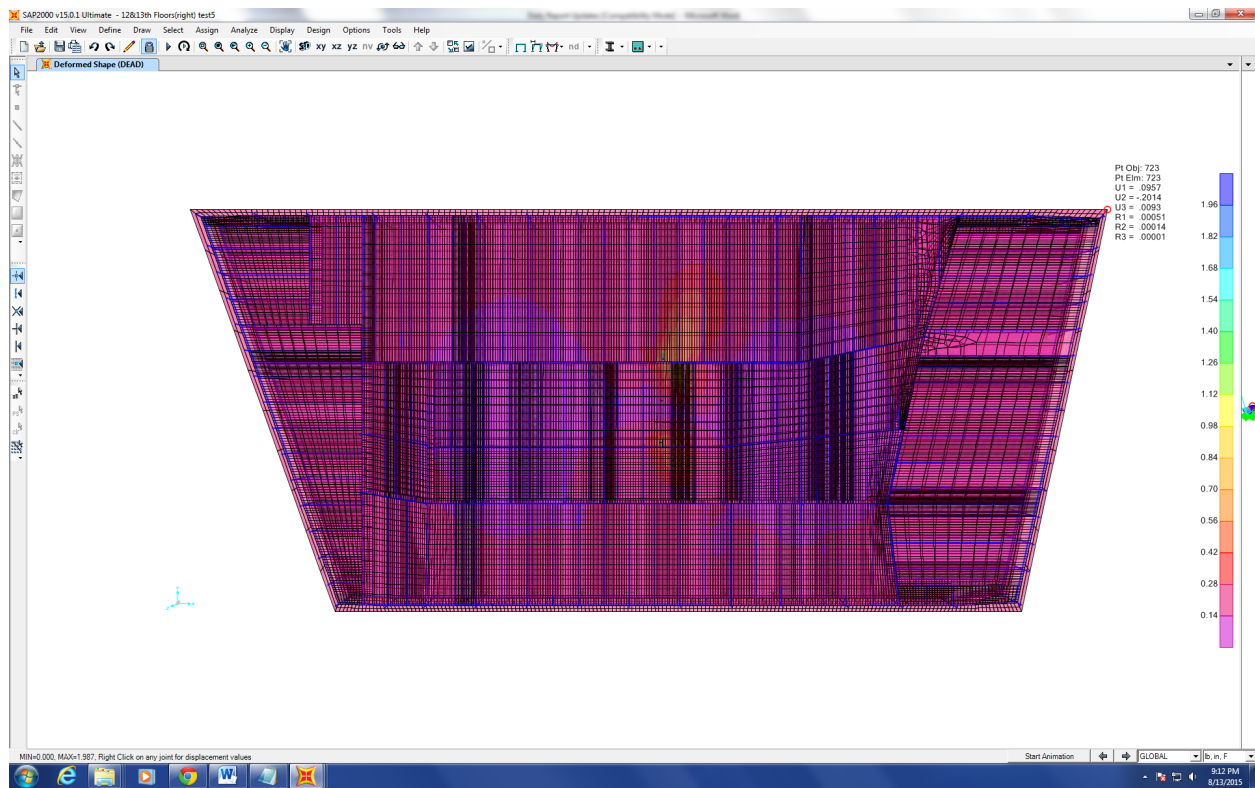
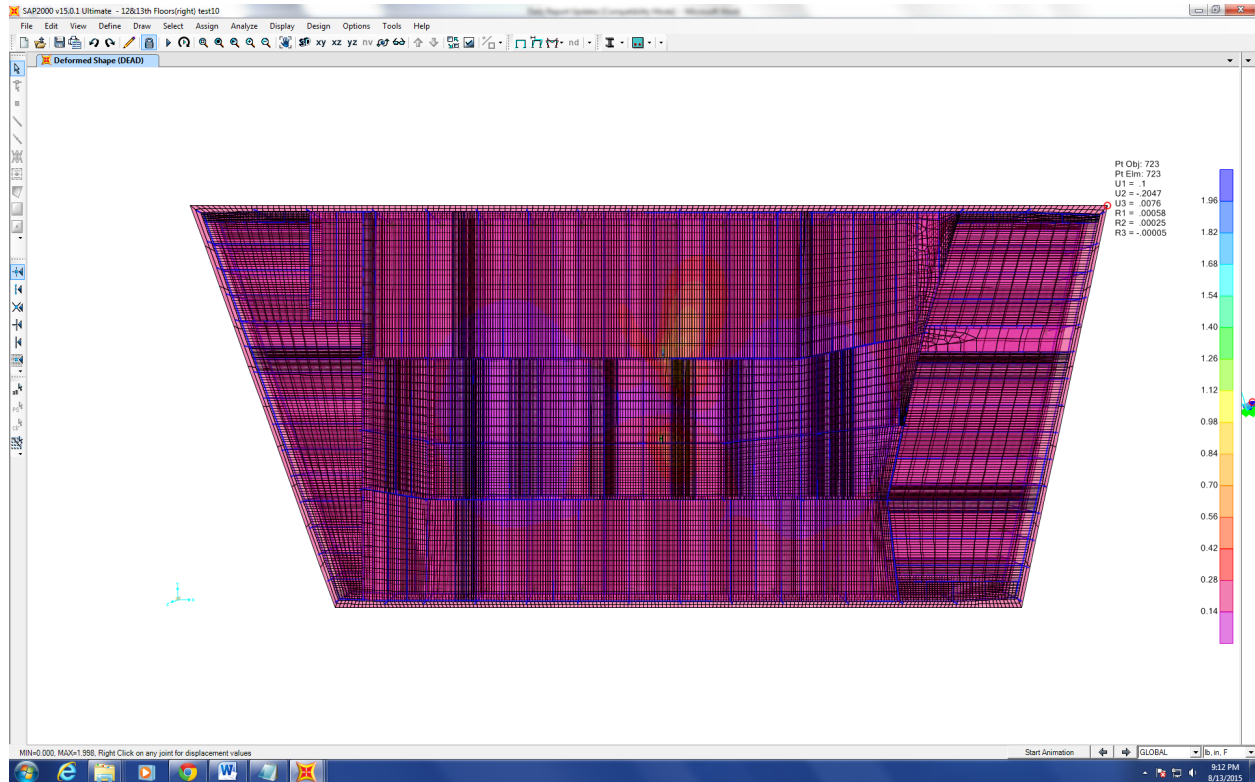
Figure 5 and 6 show the deflection of the original model and the modified model under 10,000kips in y direction respectively.

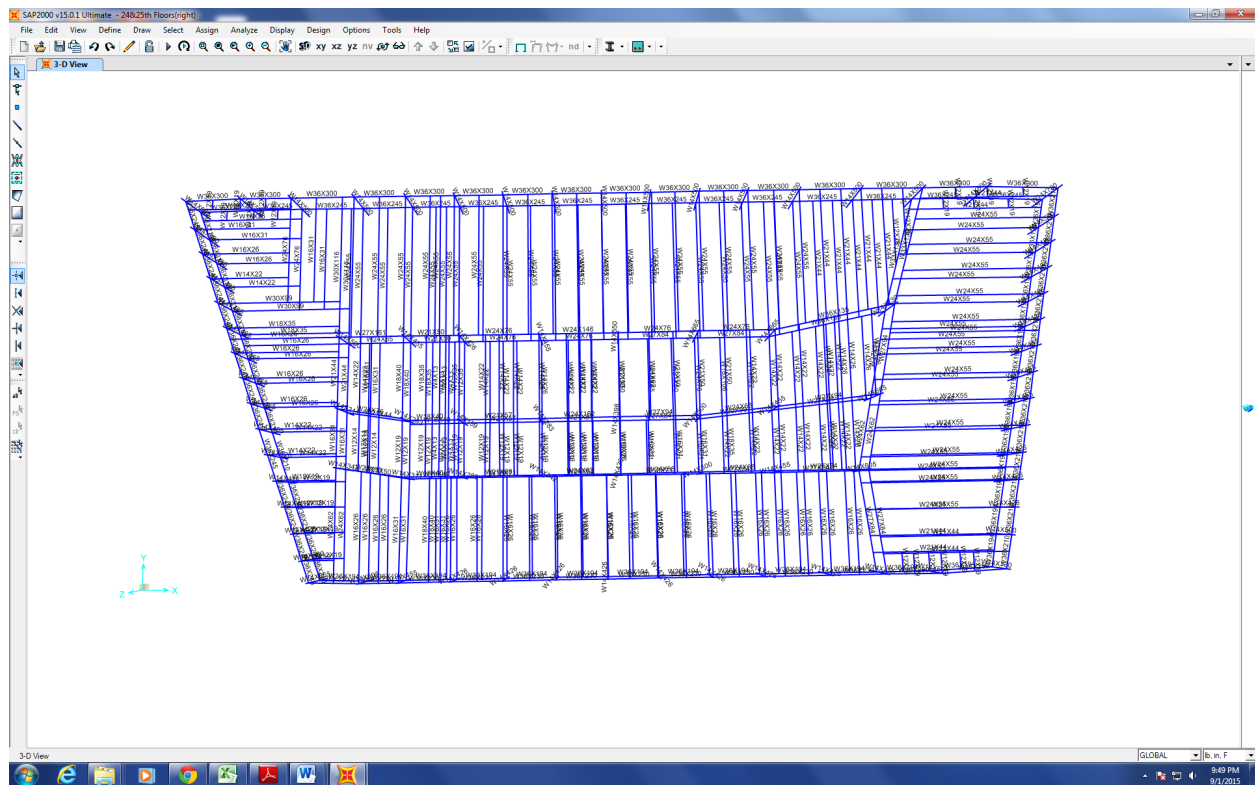
Figure 1 shows the finished 24<sup>th</sup>&25<sup>th</sup> floors combination and Figure 2 shows the partially finished 30<sup>th</sup>&31<sup>th</sup> floors combination.
